RE-EVALUATION OF THE LOWER SAN FERNANDO DAM

Report 1

AN INVESTIGATION OF THE FEBRUARY 9, 1971 SLIDE

VOLUME II: APPENDIXES A-F

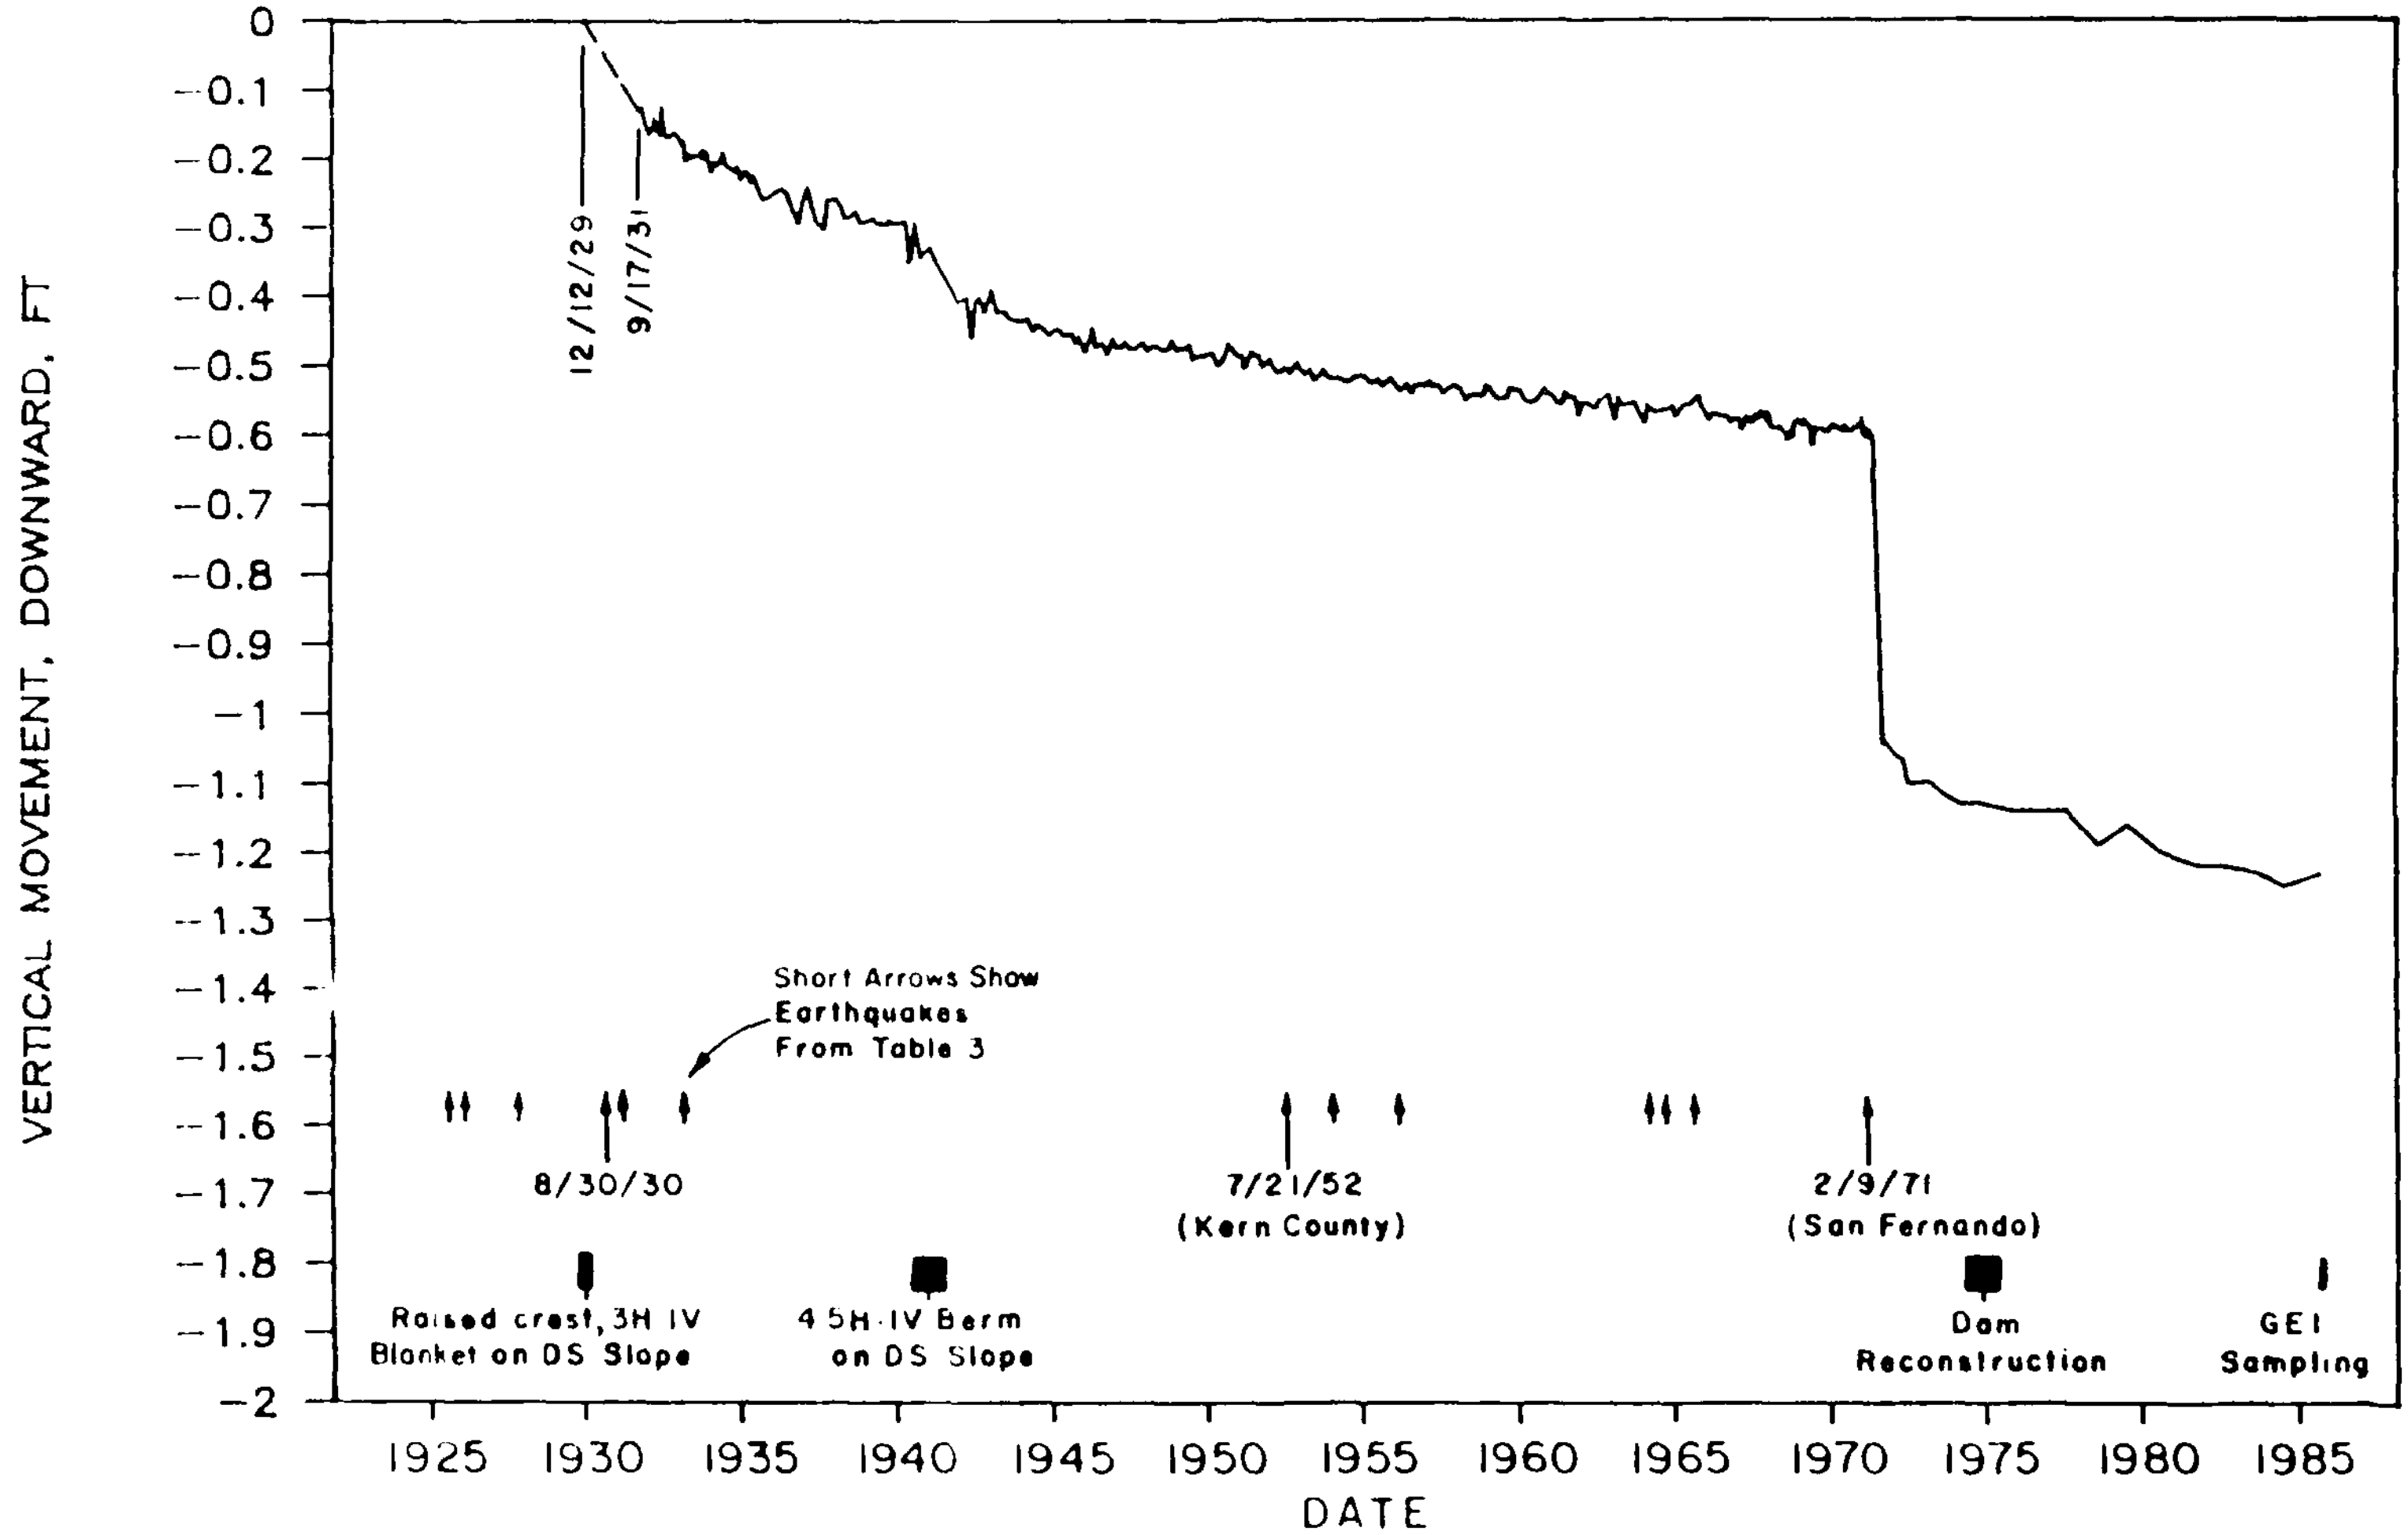
Army Corps of Engineers Vicksburg, Mississippi	Re-evaluation of Lower San Fernando Dam San Fernando, California	VERTICAL MOVEMENT VS. TIME-SURVEY POINT AT 122 FEET SOUTH STATION 6+00
GEOTECHNICAL ENGINEERS INC WINCHESTER • MASSACHUSETTS	Project 85669	August 14, 1987 Fig. C7

This void ratio change of 0.003 is corroborated by settlement measurements along the berm road (122 feet south line), shown in Fig. C7. The data indicates that the survey point adjacent to the exploration shaft settled about 0.12 feet as a result of primary consolidation which occurred in the few years following placement of the 1940 berm. Based on analysis similar to that described in Section C.5, we estimate that about 20% of the measured settlement was caused by consolidation of critical layer (Zone 5) soils. For a critical layer thickness of 15 feet and initial void ratio of 0.7, the backcalculated change in void ratio of critical layer soils is:
